# HISTORIC HEART OF GAINSBOROUGH

## 27 and 29 Lord Street

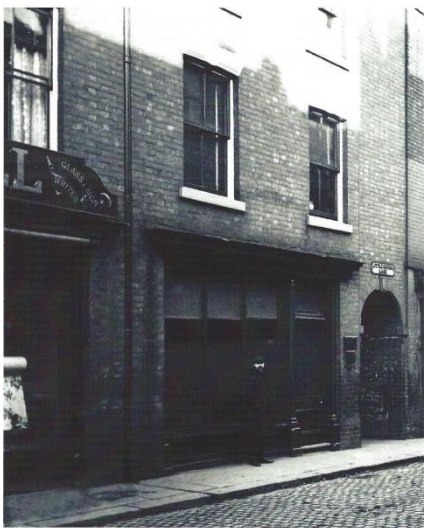
This rather dark image to the left, shows the edge of William Tall's shop window, displaying decorating materials. He had both shops for his decorating business during the early part of the 1900s until Mr Livsey the optician took over number 29 in 1917.

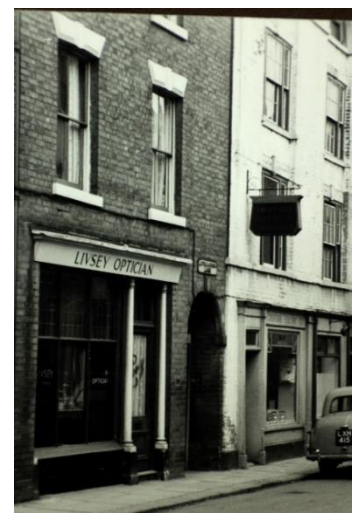
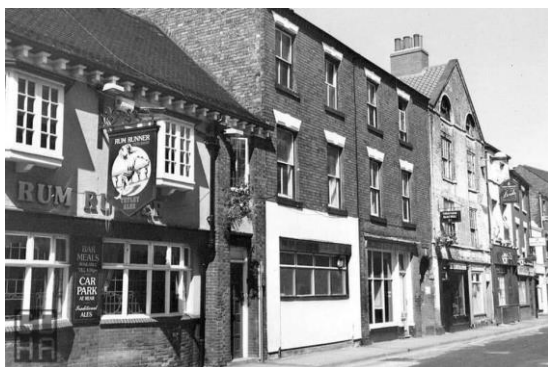
Livsey kept number 29 until 1967. The photograph to the right was taken just before he retired.

At a later stage, number 27 appears to have lost its Victorian shop front and leaded windows but a near match was subsequently reinstated.

- Allow for localised repairs to slate roof (as is not visible). Overhaul/replace cast iron rainwater goods.
- Investigate and rectify structural issue with No. 27 including brickwork and lintel repairs above shopfront.
- Localised repointing of gable brick elevation.
- Overhaul and repair/replace all 2/2 timber sash windows.
- Remove paint from stone window lintels, sills and lower portion of elevation to No. 27.
- Repair and re-lead flashings to shopfront fascia. Repaint signage on glass above entrance doors for No. 29.
- Overhaul timber shopfronts, repair green-glazed tile stallriser to No. 29 and reinstate tiling to No. 27.
